SARATOGA RACE COURSE CULTURAL RESOURCES INVENTORY

PHASE ONE:

Cultural Landscape Inventory & Architectural Resource Survey of Backstretch Structures

Produced September 2010

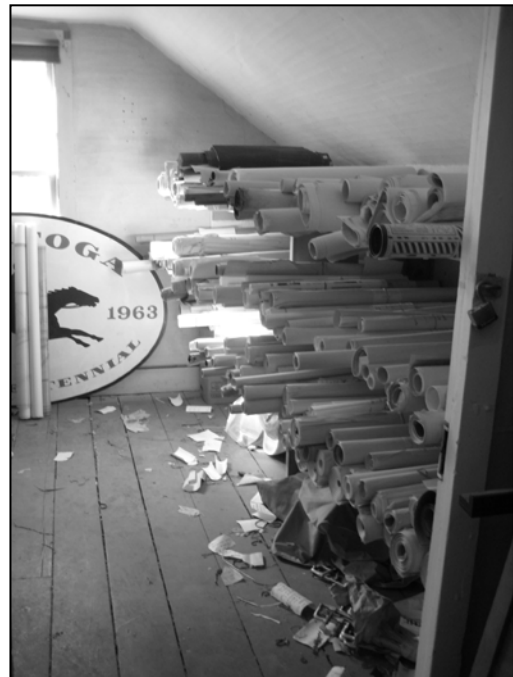
View of "plan room" on the second floor of Building #68. While a hand written list of these rolled architectural drawings does exist, there is no searchable database or any method in place for protecting these important archival resources.

During the process of researching the history of the development of the Race Course, we were given access to a storage room on the second floor of Building #68 which houses the Facilities Management Office. The storage room contained hundreds of rolled up architectural drawings, site plans and maps, as well as files or documents on the renovations or construction efforts over the last 100+ years on the property. In particular, in this room crumbling within a plastic garbage bag, was an original Charles Leavitt drawing of the renovation plans for the grounds in 1902. Because of the environment in which this and the other drawings are stored, the printed record of the evolution of the race course is disintegrating. We were able to briefly piece together the drawing in order to have it scanned and copied, but this bag of crumbling pieces of paper is possibly all that is left of this important era. For this reason it is recommended that NYRA consider working with either the Saratoga Room at the Saratoga Spring Public Library or the National Racing Museum to move all the content of this storage room to a safe, environmentally-controlled repository where electronic/scanned copies of all the paper materials can be made for regular use by researchers and original copies can be stored and protected using archival practices.

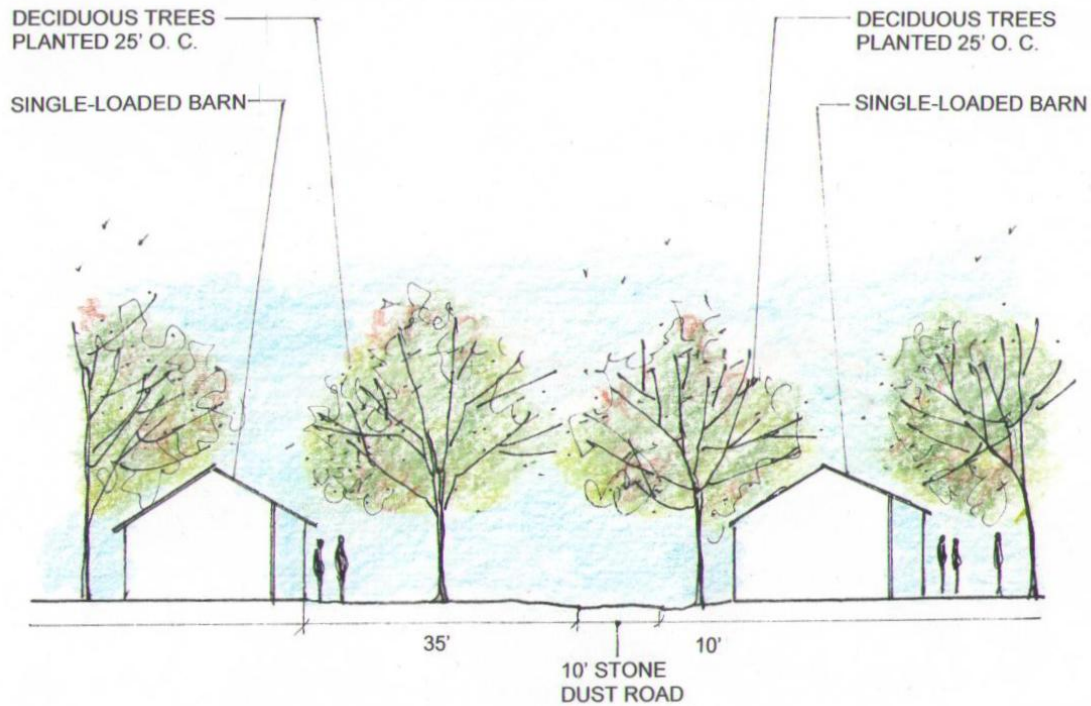
A cross-section of the reconfigured barn area shows the wider front yard, and narrower back yard, giving greater benefit to both the horses and trees.

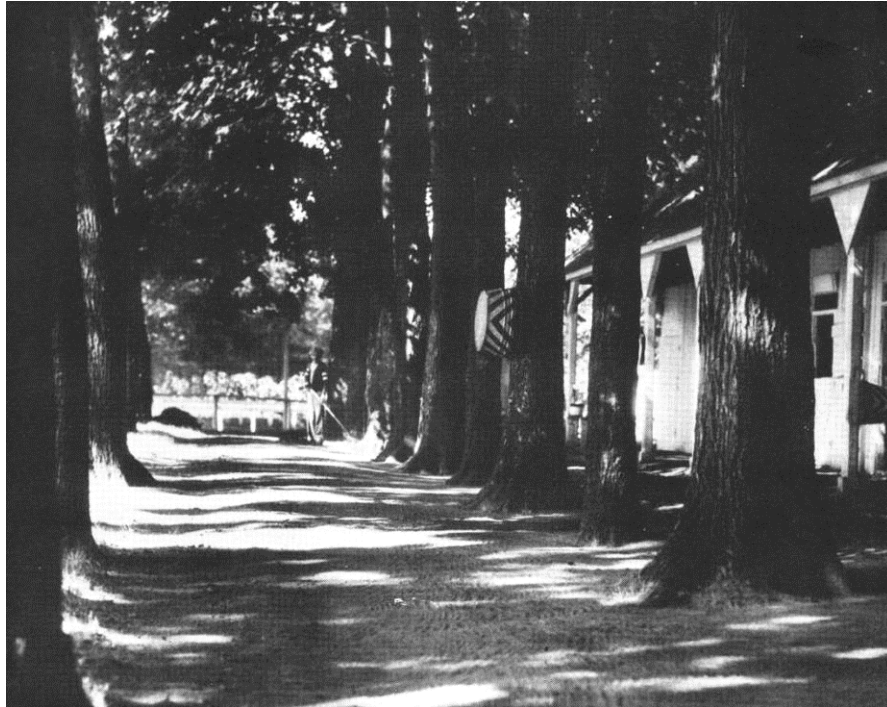
An image of Horse Haven c. 1937. The shade trees grew in even rows in front of the stables, producing a canopy of shade for the horses and stable hands. The unpaved roads allowed the trees adequate water and nutrients. Photograph from August in Saratoga, Bert Clark Thayer, 1937.

- *Barn Allees.* Several historic plans and photographs show aggressive plantings of shade trees along the front yards of the stables throughout the Course, and remnants of these plantings remain in patches. Mott's 1930 plan for stall gates showed this arrangement in the backstretch area, where maples stood as close as 20' to 25' (approximately) on center.

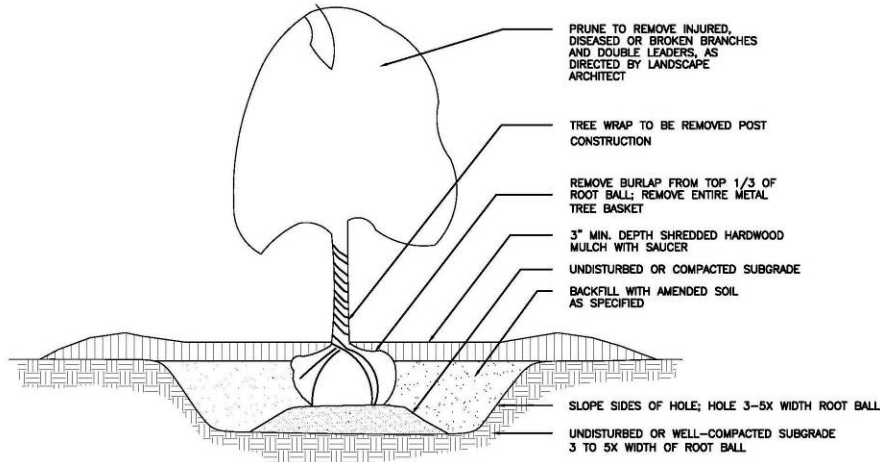
Deciduous tree planting detail. The same principles should be employed when planting evergreen trees.

- Excavate a hole twice the diameter of the root ball, and apply compost, peat moss or other organic material to the hole.
- Remove the wire cage and the top 1/3 of the burlap, allowing water and nutrients to absorb into the feeder roots.
- Leave the root collar exposed.

- Create a mulch ring around the base of the tree – DO NOT APPLY GRASS SEED or SOD.
- Do not use tree stakes unless planting is taking place in an extremely windy area.
- After planting, remove all stakes, support devices, tree tags.
- Water trees on a regular basis throughout the season after initial planting

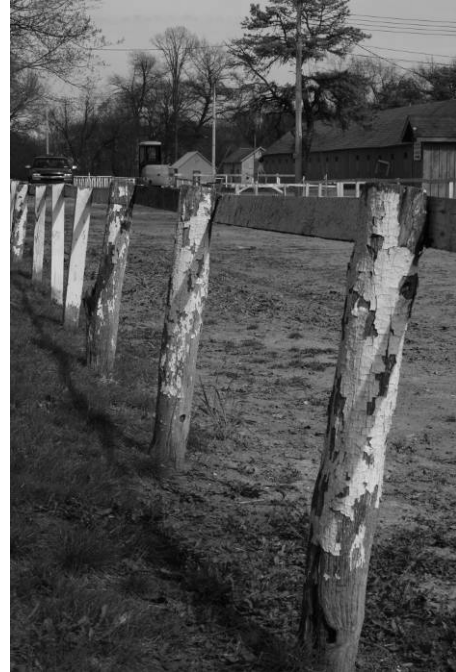
The original timber fence lining the historic Horse Haven track. Many timber members have been removed and replaced with 4" x 4" posts. The original timber design should be reconstructed.

- *Main and Oklahoma Tracks*, where specialty fencing has been installed and should remain for the safety of horses and jockeys;
- *Historic Horse Haven Track*, where some historic wood timber posts remain, but most have been replaced with 4" x 4" wood posts, painted white. Both sides of the track should contain reconstructed timber posts, spanned by 1" x 4" cedar rails, stained white.

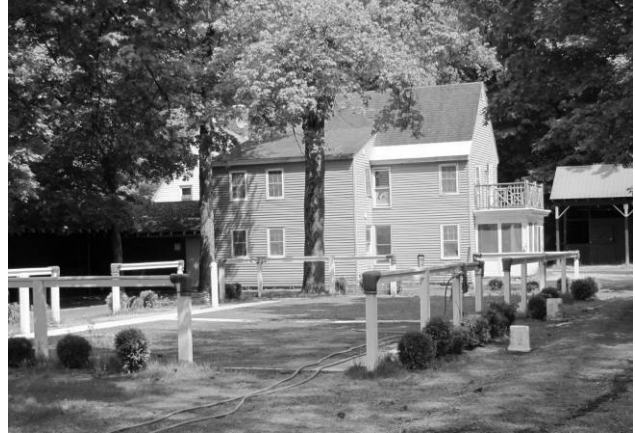
The washstand at Dupont provides an example of how this very necessary but utilitarian feature can be softened with plantings, and as a result, blend more seamlessly with the surrounding Race Course landscape.

The Race Course's wash stand prototype consists of a rectangular concrete slab with center drain, surrounded by a 4' high single-rail vinyl fence (an exception has been made to this material in some spots where the fencing is built out of wood). Most have been placed in open lawns near the barns and exhibit no other detail. At Dupont, a boxwood hedge has been cultivated around the outside of the fence, making the feature meld better with its surroundings. Nearby shade trees further soften the washstand's imprint on the landscape. Similar applications of shrub plantings should be made throughout the Race Course. Suggested shrub species include:

<i>Buxus microphylla</i>	Boxwood
<i>Cornus sericea</i>	Redosier Dogwood
<i>Hydrangea arborescens</i>	Smooth Hydrangea
<i>Ilex crenata</i>	Japanese Holly
<i>Ilex glabra</i>	Inkberry
<i>Ligustrum obtusifolium</i>	Border Privet

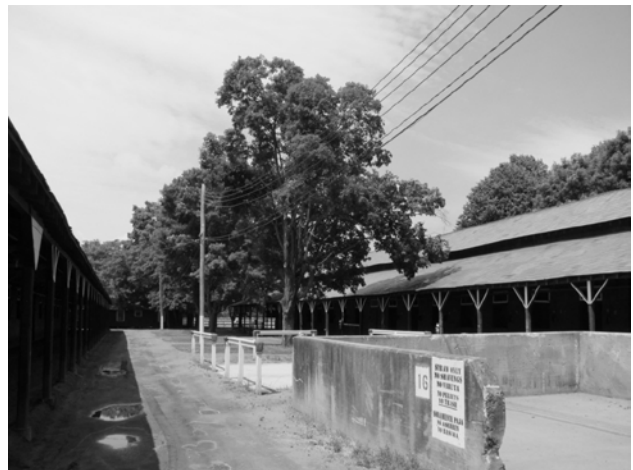
A muck storage bin at Madden Court typifies the crude, unfinished look of this ubiquitous Backstretch feature.

The Race Course's muck storage prototype consists of a three-sided poured concrete bunker-type structure, open on the fourth side to facilitate loading and unloading. They remain unpainted and are therefore prone to absorbing stains and spurring the growth of mold. A necessary feature of the backstretch area, their unkempt appearance has turned them into eyesores in the Race Course landscape. As with the wash stands, the bins' look could be upgraded through with the following additions/modifications:

- Apply an oil-based paint to the surface of the concrete in a color that blends with the surrounding environs, such as a pale green or khaki color.
- Plant low shrubs and/or vines around the outside of the structures to obscure the plain concrete walls (see wash stands for suggestions of species).
- Construct wood fences around the outer three sides of the structures to obscure the plain concrete walls.

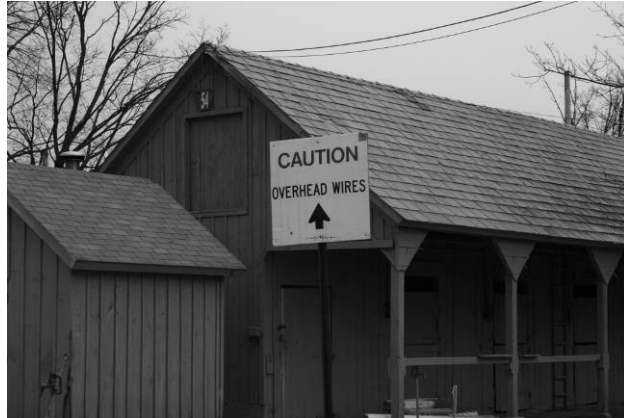
In East Horse Haven, NYRA placed this sign near the end of a barn complex, warning riders about the danger of low-lying overhead utility lines.

Overhead utility lines thread throughout all areas of the backstretch (both north and south of Union Avenue), creating visual clutter and posing a safety threat to riders on horseback (many lines lie low). By removing these lines and placing them underground, the Race Course can accomplish the following:

- Reduction in visual clutter from fewer overhead wires and utility poles;
- Increased safety for riders;
- Easier, more efficient maintenance of utility lines.

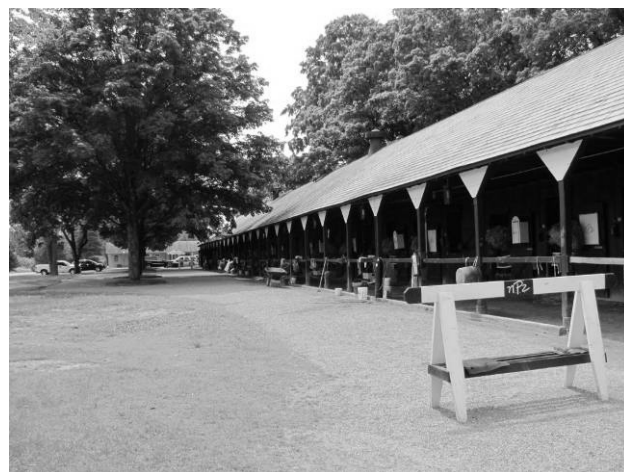
The environs of barn #84, occupied by Nicholas P. Zito's establishment, has been enhanced by the addition of peastone paving, wood timber trim around the bases of trees, and tables, chairs and umbrellas for outdoor eating.

In a few areas throughout the backstretch, individual farms and horse owners have cultivated the environs of the stables they occupy to meet their individual tastes. Efforts range from simply placing banners across stall doorways; to hanging pots of annual flowers from barn roof overhangs; to developing the entire landscape, including paving, planting and site furnishings. The Race Course should encourage these efforts, as they add to the character and beauty of the landscape. To place some parameters on the extent of landscape improvements allowed, the Race Course should develop guidelines to be used by individual farms/horse owners.
