SARATOGA RACE COURSE CULTURAL RESOURCES INVENTORY

PHASE TWO:

Cultural Landscape Inventory & Architectural Resource Survey of the Frontside & Back Yard

Produced May 2011

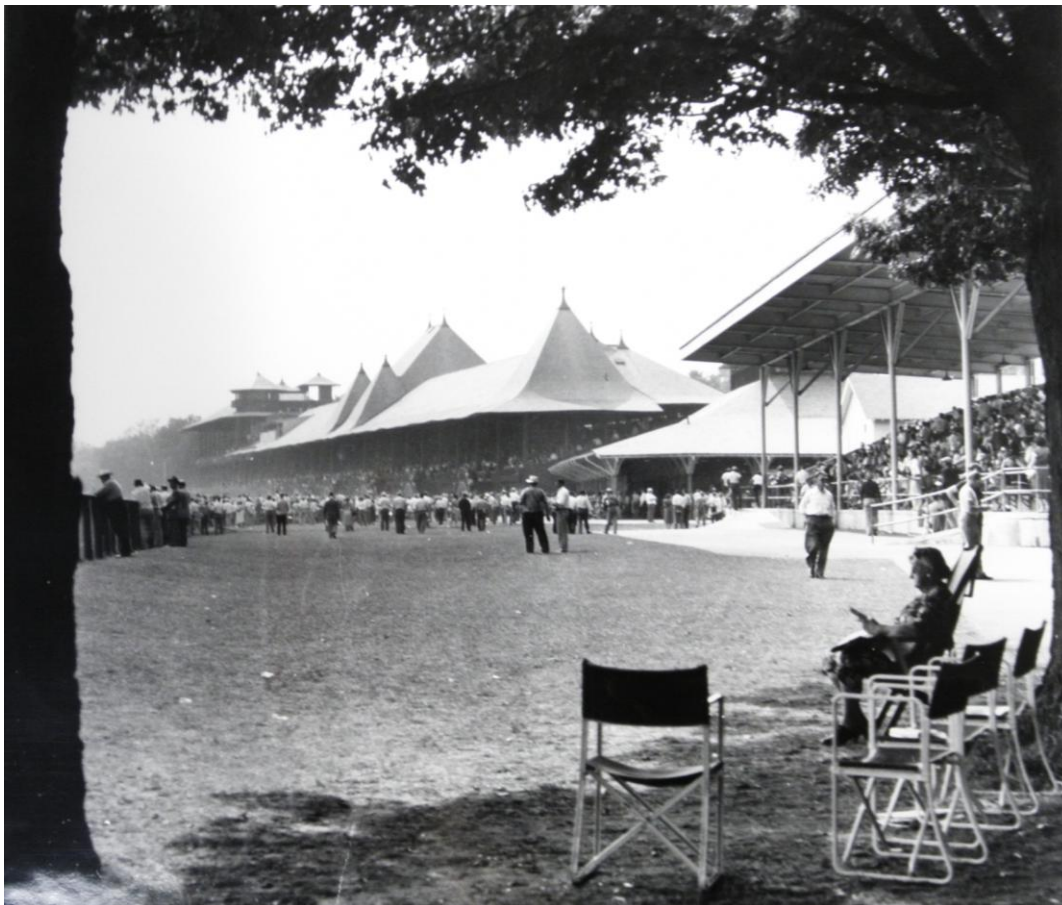
View of Main Track “Apron” looking west, c. 1951. (Saratoga Springs History Museum, George Bolster Collection, H. B. Settle, photographer).

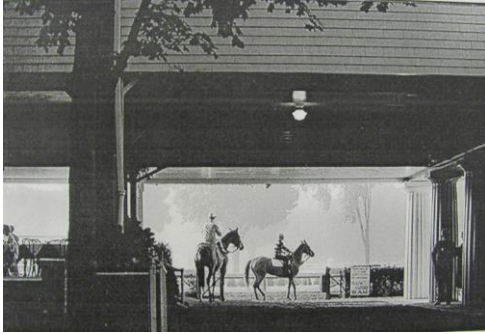
Image of horse path through Clubhouse, prior to 1977. (Saratoga Springs Public Library, Saratoga Room Collection)

and horses cramped into a single undersized area. The layout of features compromises the safety of all involved. To remedy this problem, NYRA should restore the vehicular circulation pattern devised by Leavitt in 1902; remove the general admission gate; create a drop off for clubhouse patrons; create a handicapped parking area; and re-route the horse path (in conjunction with a clubhouse restoration).

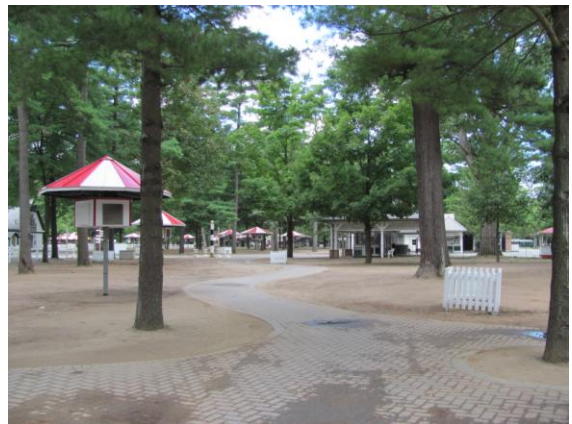
Illustration of the vast number of features in the Back Yard, the expanse of pathways and loss of grass lawns.

NYRA has, over the past several decades, gradually filled the back yard, paddock area, and north portion of the main track apron with numerous small structures, arranged haphazardly. These include concession buildings and stands (both temporary and permanent), simulcast television umbrellas, picnic tables, a children's playground, para-mutuel windows, benches, trash bins, overhead utility lines and appurtenances, and long stretches of overhead canopies, supported by an array of piping materials. Because the number and placement of these structures was never part of an overall site plan, NYRA crews added them at random. Once in place, patrons began accessing them by crossing over the back yard lawns, compacting the soil, damaging the trees, and creating wear paths. To "neaten" the paths, NYRA covered them with permanent, impervious pavement. The more NYRA added little structures, the more wear paths were formed, and the more paved surfaces resulted. And, the many new paths resulted in many more crossings of the horse path, and to control conflict between patrons, NYRA erected endless stretches of fences. By removing and/or consolidating these structures, NYRA can recapture the back yard's character as it was during the period of significance. Critical to this de-cluttering effort will be the re-location of the children's play equipment and picnicking area away from the back yard.

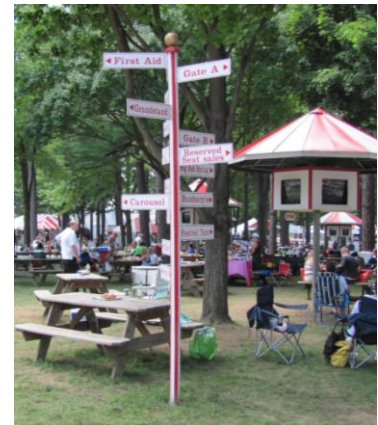
Current attempt to provide direction in Back Yard.

Once the many little structures and multiple functions have been consolidated into fewer buildings, NYRA can then focus on cleaning up the maze of roads, paved pathways, and horse paths weaving throughout the back yard. As a rule, NYRA should make every attempt to reduce the number of pedestrian, vehicular and horse conflicts throughout. The simplified circulation plan should include a streamlined vehicular roadway system; pedestrian walkway system connecting to the buildings; a preserved horse path with modified edges; and a hierarchy of road and path materials, selected from a defined palette of landscape materials (discussed below), with an emphasis on porous paving throughout.

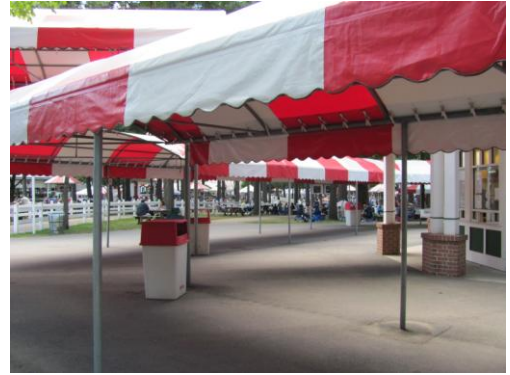
An example of one area of dense canopy coverage.

cover the rear roof terrace, that was originally intended to be open-air and open to the summer weather. Unfortunately, these *seasonal* canopies consist of removable fabric, but permanent aluminum framing. In some cases the aluminum frames have been anchored to copper flashings on the roofs and have contributed to corrosion. In other areas, they are set into the ground into concrete footings. It is urged that despite these “permanent” frames, that the canopies be removed or greatly reduced in quantity. The purpose of the canopies should be simply to indicate an entry point or to provide a small and occasional shade from the summer sun where no other shade is provided.

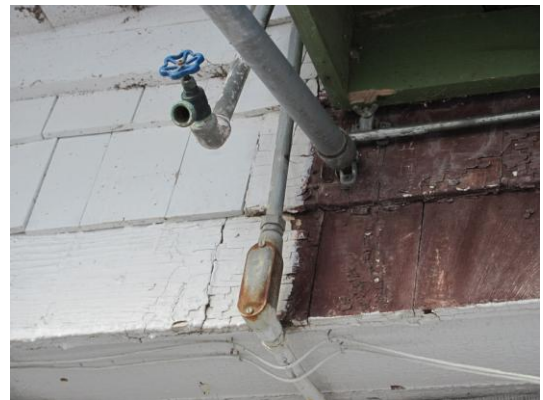
Without a define exterior aesthetic that is based on architectural history and understanding by maintenance staff of why and where certain paint colors should be applied, situations like this result where the historic stained shingles are partly coated with the universal “white paint.”

Starting in the 1940s and continued with universal application in the late 20th century, the buildings whether dating to the 1890s or the 1990s were all painted white with green trim and in some cases accented with bright red to match the red & white striped canopies. For many, the white, red and green colors are associated with the aesthetic of Saratoga Race Course. In fact the NYRA and Saratoga logo that has been used since the 1960s includes these colors and reference to the striped awnings. However, the plethora of historic images dating from the 1890s, the early 1900s when Whitney presented the new and improved Saratoga race course and up to the Second World War, white paint was a rare sight. In fact, white was a rare color choice for Late Victorian or Shingle style structures, which the Grandstand, Clubhouse and other early structures were designed in. It is suggested that instead of applying a universal color scheme to all the buildings regardless of age and style, that an exterior aesthetic and paint schemes be defined based on the style and age of a building. For example the c. 1892 structures should stand out from the 20th century structures where possible with a rich, darker, Victorian-era color scheme. This allows patrons to recognize that these are older and distinguish them from contextual, but recent structures. For recent structures, a complementary but unique color palette should be defined and applied. Not only does this approach restore the historic and architectural appearance in the back yard, it provides an opportunity to educate the patrons on the architectural heritage of the site and foster an appreciation for the preservation efforts of NYRA.

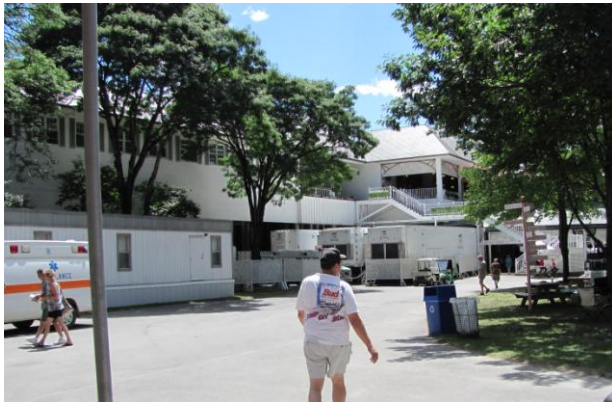
With the need for track related offices, service vehicles, and utilities the current solution has been to fill the back yard and ground floor areas around the Grandstand and other structures with trailers, utility & media vehicles, generators, and other support items that detract from the historic character of the Back Yard.

It is acknowledged that the late 20th and early 21st century demands technology, systems, and code compliance in a way that was not a priority 100 years ago. As a result there is a need to introduce a variety of systems, equipment and services to the buildings in order to meet modern requirements. This is always a tricky endeavor when working with historic structures where mechanicals were not an original consideration in their design and construction. However, although tricky, the successful introduction of systems and equipment is not impossible. It just requires extensive planning, careful execution and a wide-spread understanding among all players involved that the original fabric of the historic structure has significant value, is generally irreplaceable and must be approached in a sensitive manner. The goal of introducing systems into a historic structure and landscape is to minimize the visibility particularly in the highly significant spaces, and for the installation to be fully reversible in the event that they equipment or system needs to be upgraded or that it may no longer be necessary.
